ABS Pump Relays & Fuses

Item: [PRC9603](#)

Fits: Range Rover Classic | '90 - '95

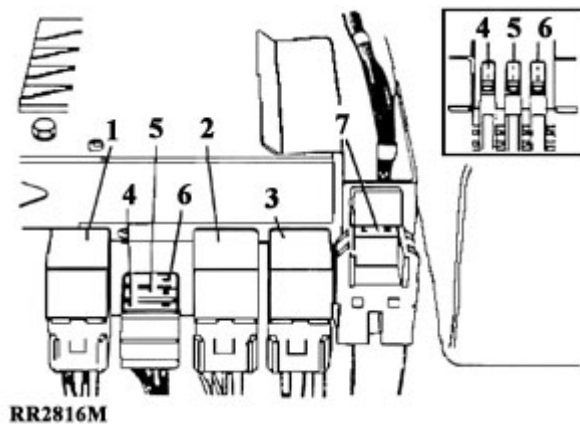
Relay fuse identification (RR2816M)

1. ABS warning light relay, green base - AB12
2. Valve relay, black base - AB14
3. Hydraulic pump relay, black base - AB2
4. Hydraulic pump relay fuse, 5 amp tan - AB10
5. Stop light switch, diagnostic plug, ECU pin 9 fuse. 5 amp tan - AB11
6. Valve relay fuse, 25 amp white - AB13
7. Hydraulic pump relay fuse, 30 amp green MAXI type fuse - AB1

Fuse position on early 1990 vehicles.

Incorporated in the ABS electrical system are three relays, located beneath the left hand front seat adjacent to the ABS ECU. Access to the relays is gained by removing the seat side trim.
